# EVALUATION OF BARRIER CABLE IMPACT PAD MATERIALS

T.B. HUSBANDS, D.L. BEAN

USAESWES  
STRUCTURES LABORATORY  
P.O. BOX 631  
VICKSBURG MS 39180-0631

MARCH 1988

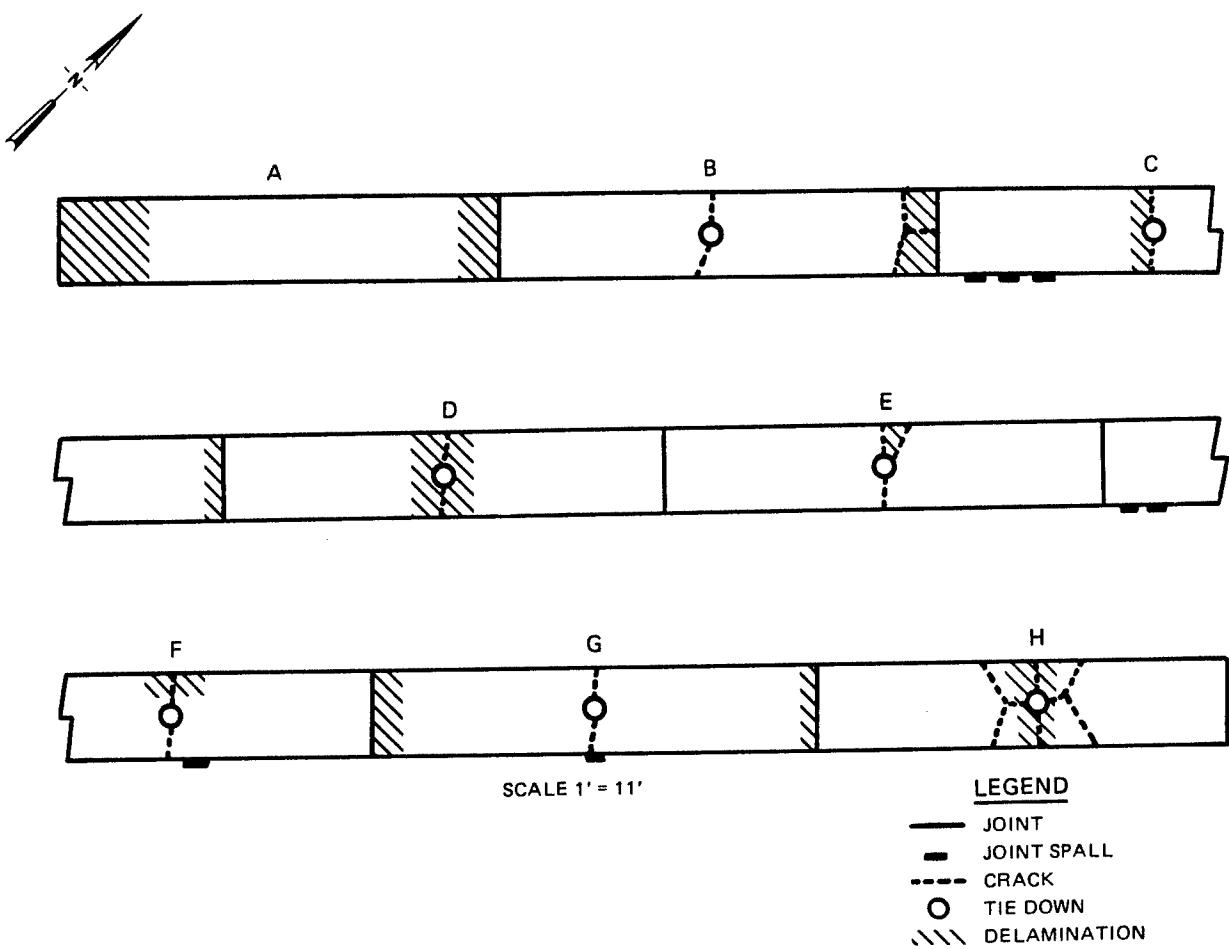
Figure 16. Plan View of W-EP-3 Pad on Northwest End of 13L Runway.

On 12 March 1983, WES inspected the barrier pads of Tyndall AFB. Figures 16 and 17 illustrate the sections of the two pads that contain the W-EP-3. The cracks, spall areas, and the suspected delaminated areas are shown on the figures.

The inspection revealed cracking, suspected delamination in the W-EP-3 grout, minor surface scaling in the W-M-3, and surface abrasion in both systems. The problems encountered with the W-EP-3 product appeared to be the results of the epoxy shrinking or the difference in coefficient of thermal expansion. Figures 18-20 indicate that some lifting occurred, resulting in delamination. These areas and others next to the cracks were sounded by tapping with an iron rod. Areas that sounded hollow were labeled as delaminated. Figures 21-23 illustrate typical cracks in the pad. The scaling in the W-M-3 material is shown in Figures 24-26.

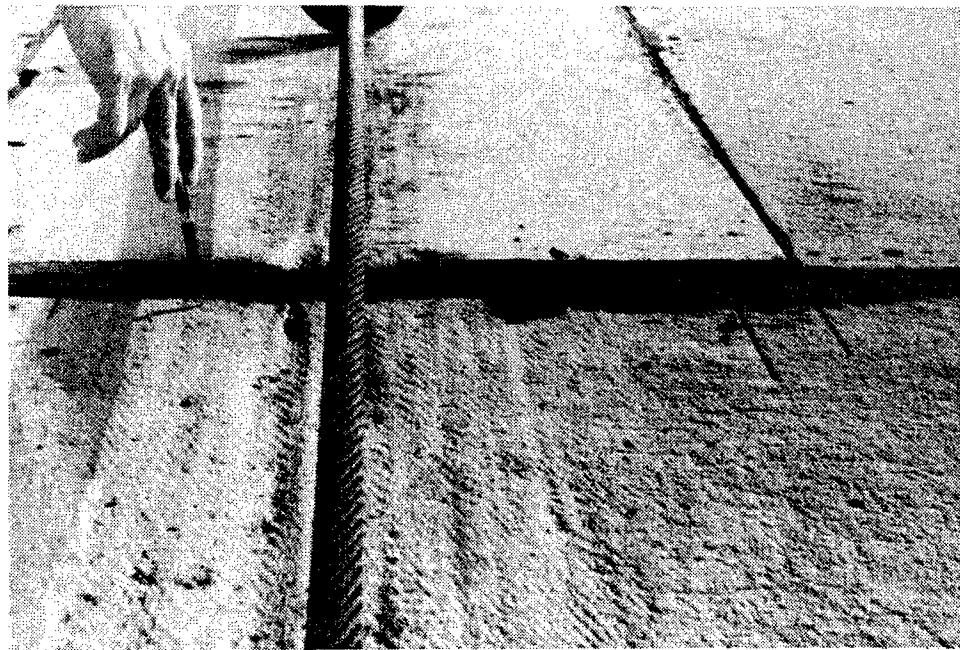
The erosion of the concrete adjoining the displaced west end of the northwest pad (Figure 18) indicates that the pad was level with the concrete before being displaced upward. This is indicated by the presence of the abrasion marks on both the pad (background, Figure 18) and the concrete (foreground, Figure 18). Figure 20 shows the apparent lifting of the end of the panel and the cracking of the corner. The corner broke loose and settled to its original level.

Figure 18. Lifting of the Ends of Panel A.

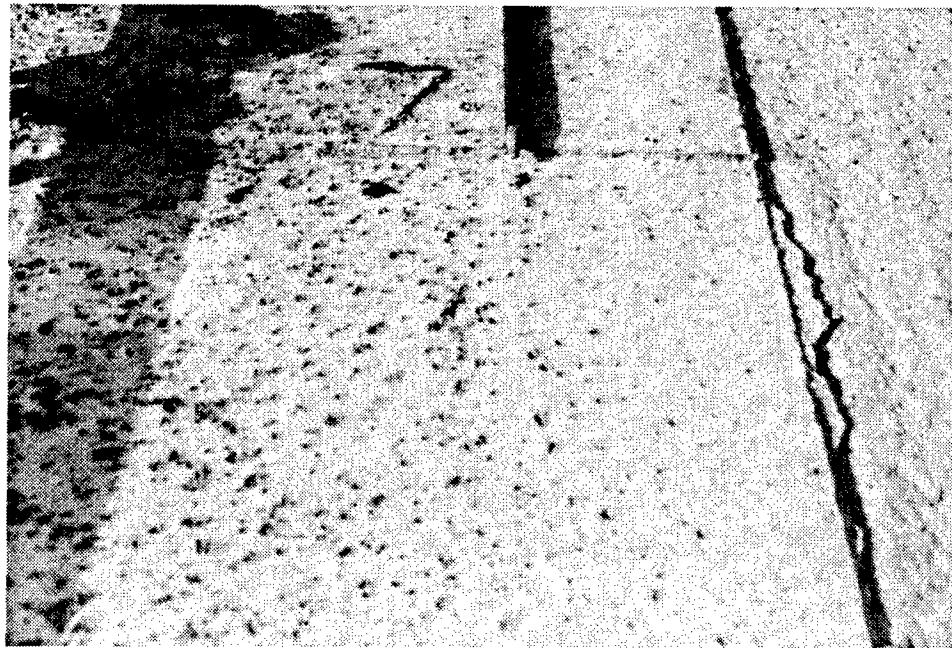
Figure 19. Lifting in Panel F.

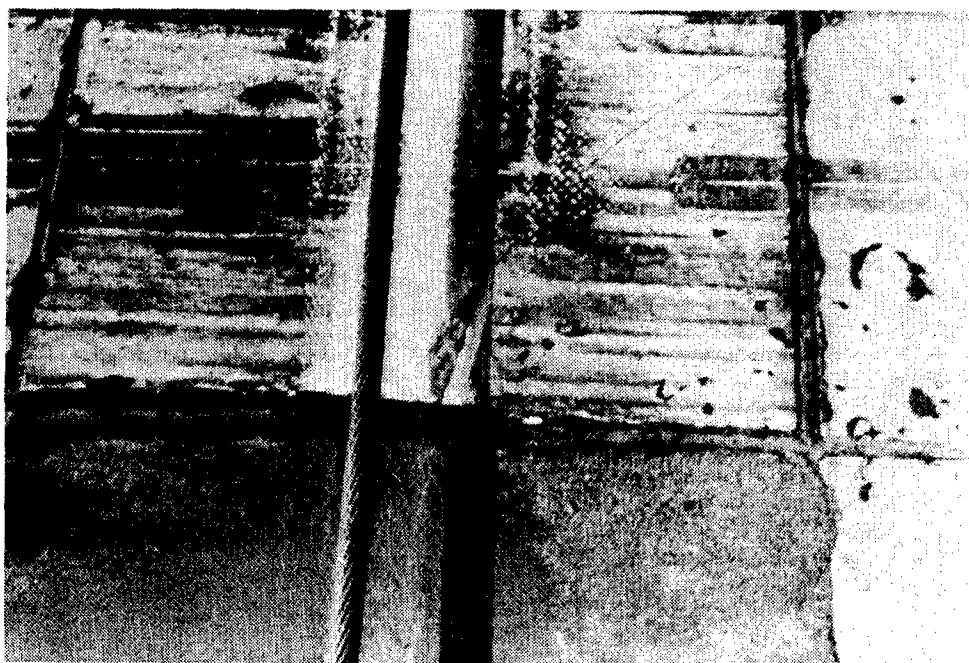
Figure 20. Lifting and Failure of the Corner of a Panel in the Middle Runway, Northwest End of the Panel.

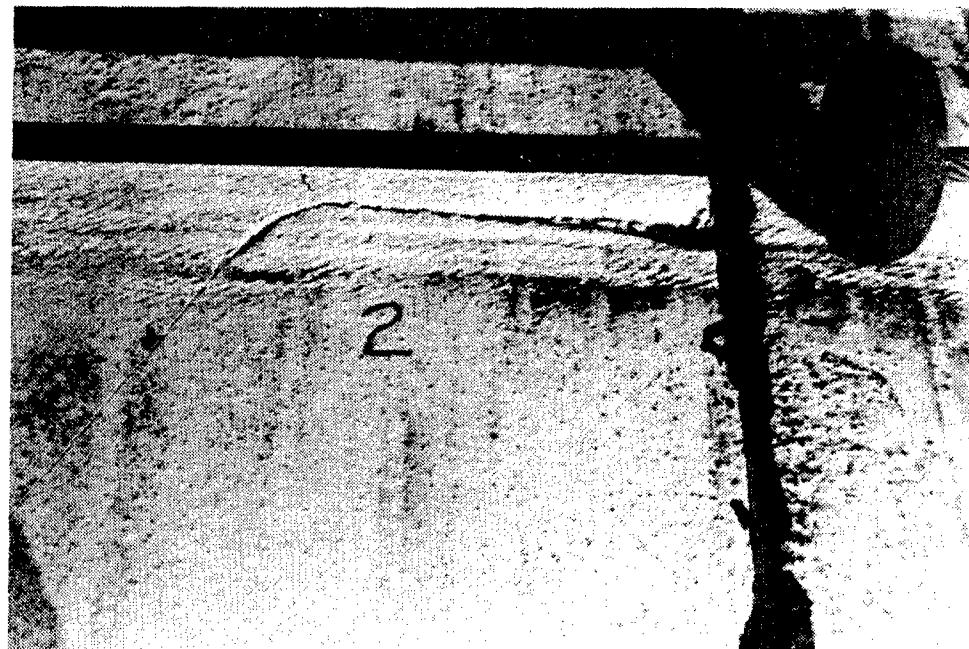
Figure 21. Diagonal Crack in Panel B.

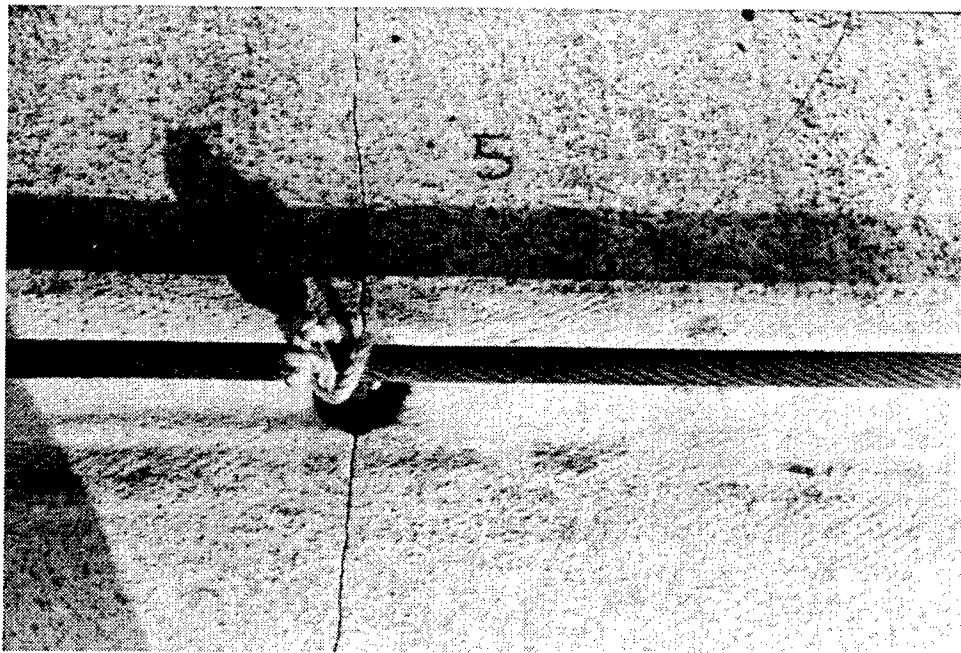
Figure 22. Transverse Crack in Panel E.

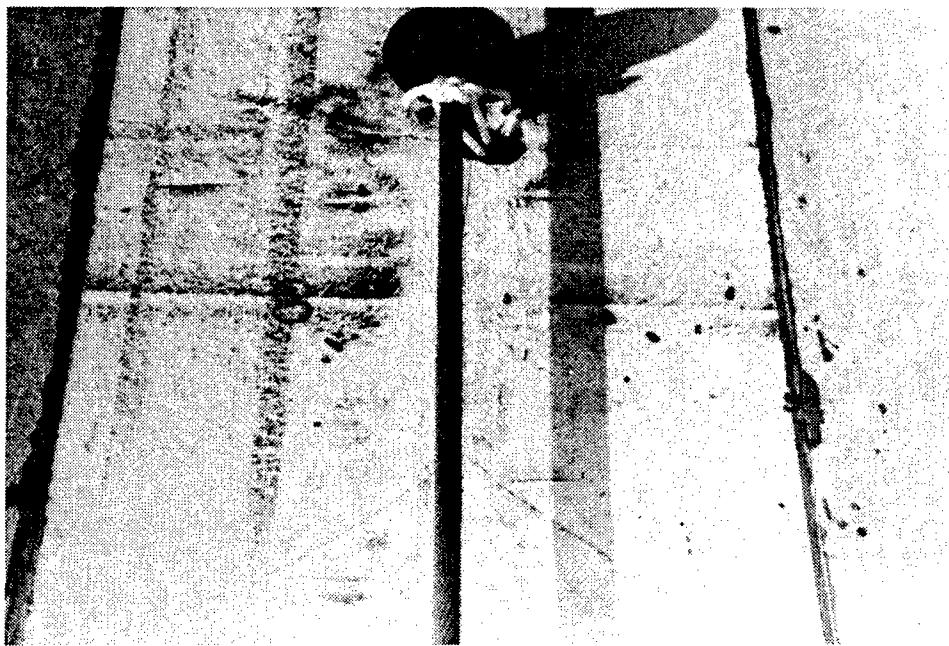
Figure 23. Diagonal Cracks in Panel H.

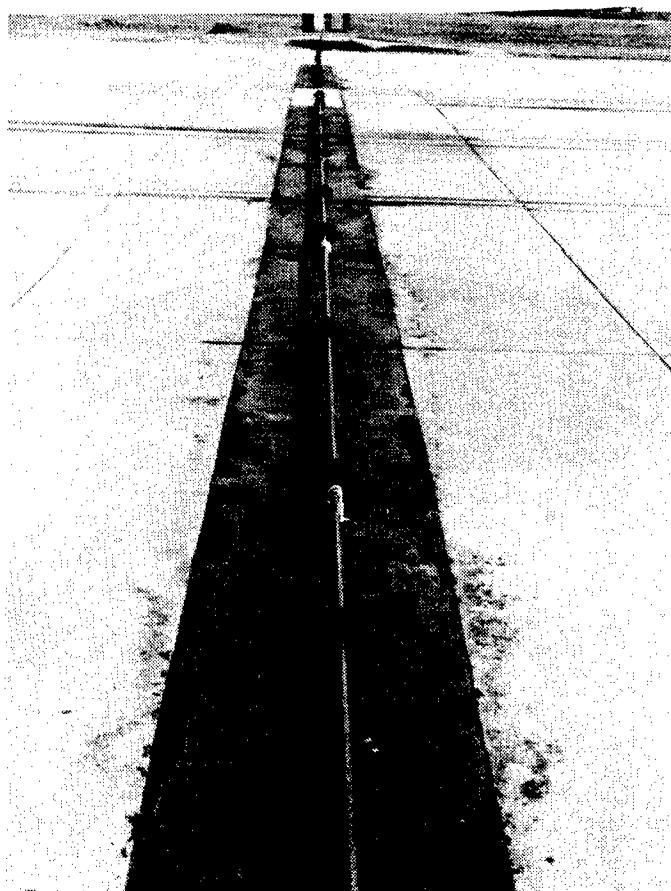
Figure 24. Scaling in  
W-M-3 Pad.

The scaling of the W-M-3 occurred only in areas adjoining the concrete. When the W-M-3 is poorly consolidated, it is more susceptible to weathering and can be deteriorated faster than the properly consolidated material. It appears that the consolidation equipment, a Kelly float, could not properly consolidate the material next to the concrete because the concrete was partially supporting the equipment. This could be a reason why scaling only occurred in areas adjoining the concrete.

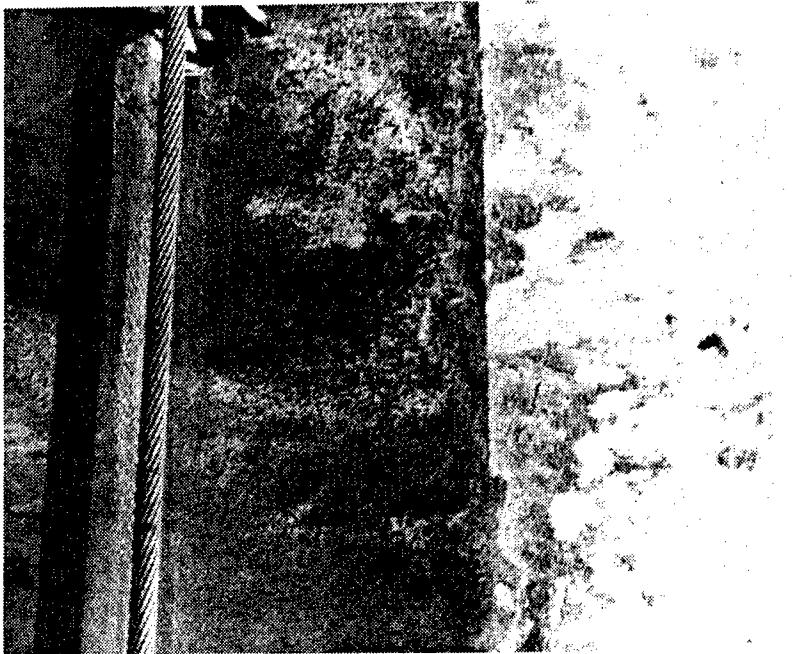
Figure 26. Scaling and Excess W-M-3 on Pavement.

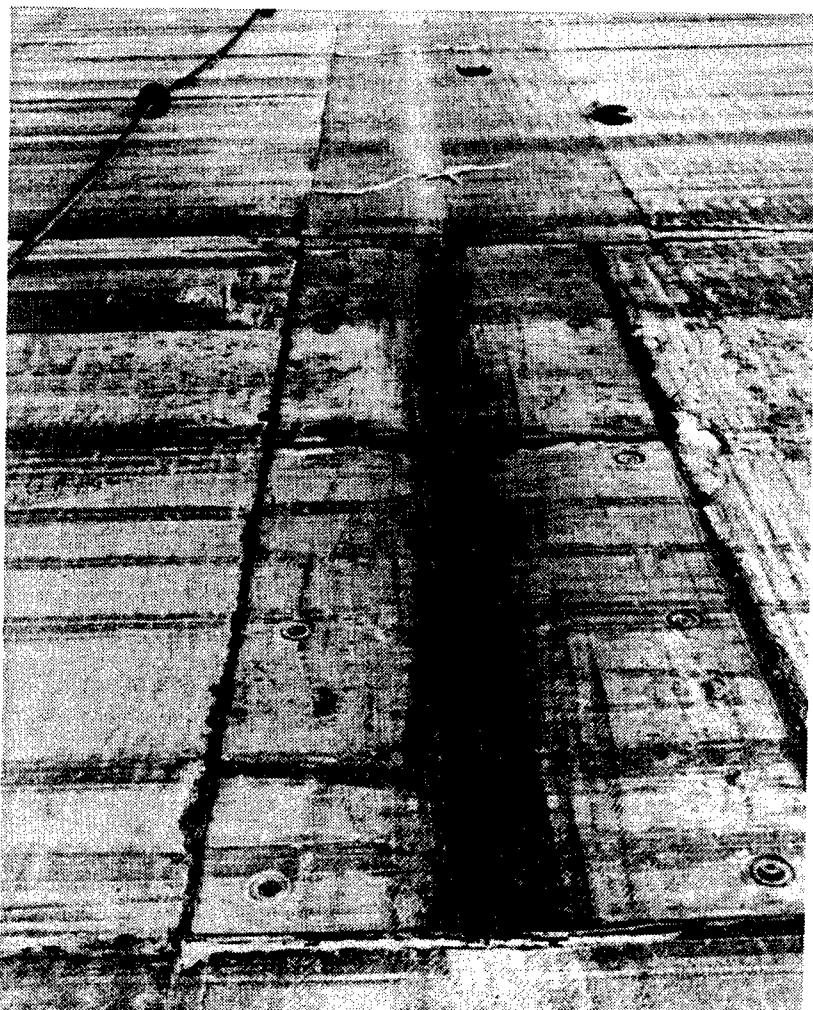
Approximately 1 month after the installation of the preformed polyurethane pads, it was reported that the pads had started to warp (Figure 40). The two pads were turned over and the warping was eliminated for a time but could reoccur. The pads were being turned over at least once a month. After 9 months of service the pads had started to warp to such an extent as to justify removal. Torn places in the pads below the cable were also observed (Figure 41). The tears in the polyurethane pads were due to metal plates that were installed at form holes during the manufacturing process to center the wire mesh. The cable had started to bow the small metal plates causing the plates to protrude through the pads.

Figure 40. Warpage in the Polyurethane Pad.

When contacted, the manufacturer of the polyurethane pads recommended that the design of the wire mesh be changed slightly and the metal plates removed. The manufacturer also recommended that the bolts be tightened with a torque wrench to obtain 25 foot-pounds and then the force reduced by turning the wrench one-fourth turn in the opposite direction. Two of the polyurethane pads having the new design were ordered for replacement of the two placed in service earlier and were installed on 19 October 1985.

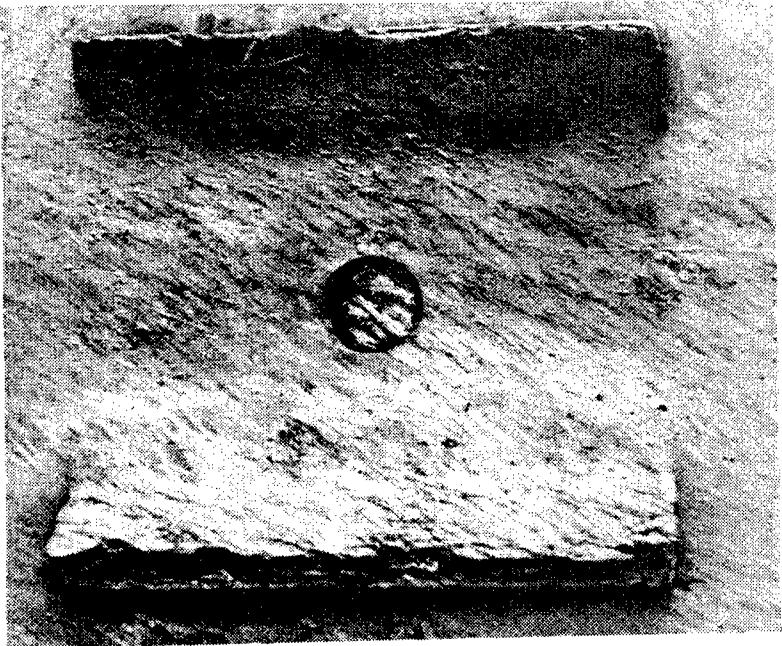
Figure 41. Deterioration within the Polyurethane Pad.
